19.0 Tuba City, Arizona, Disposal Site

19.1 Compliance Summary

Figure 19-1. 2003 Annual Compliance Drawing for the Tuba City, Arizona, Disposal Site

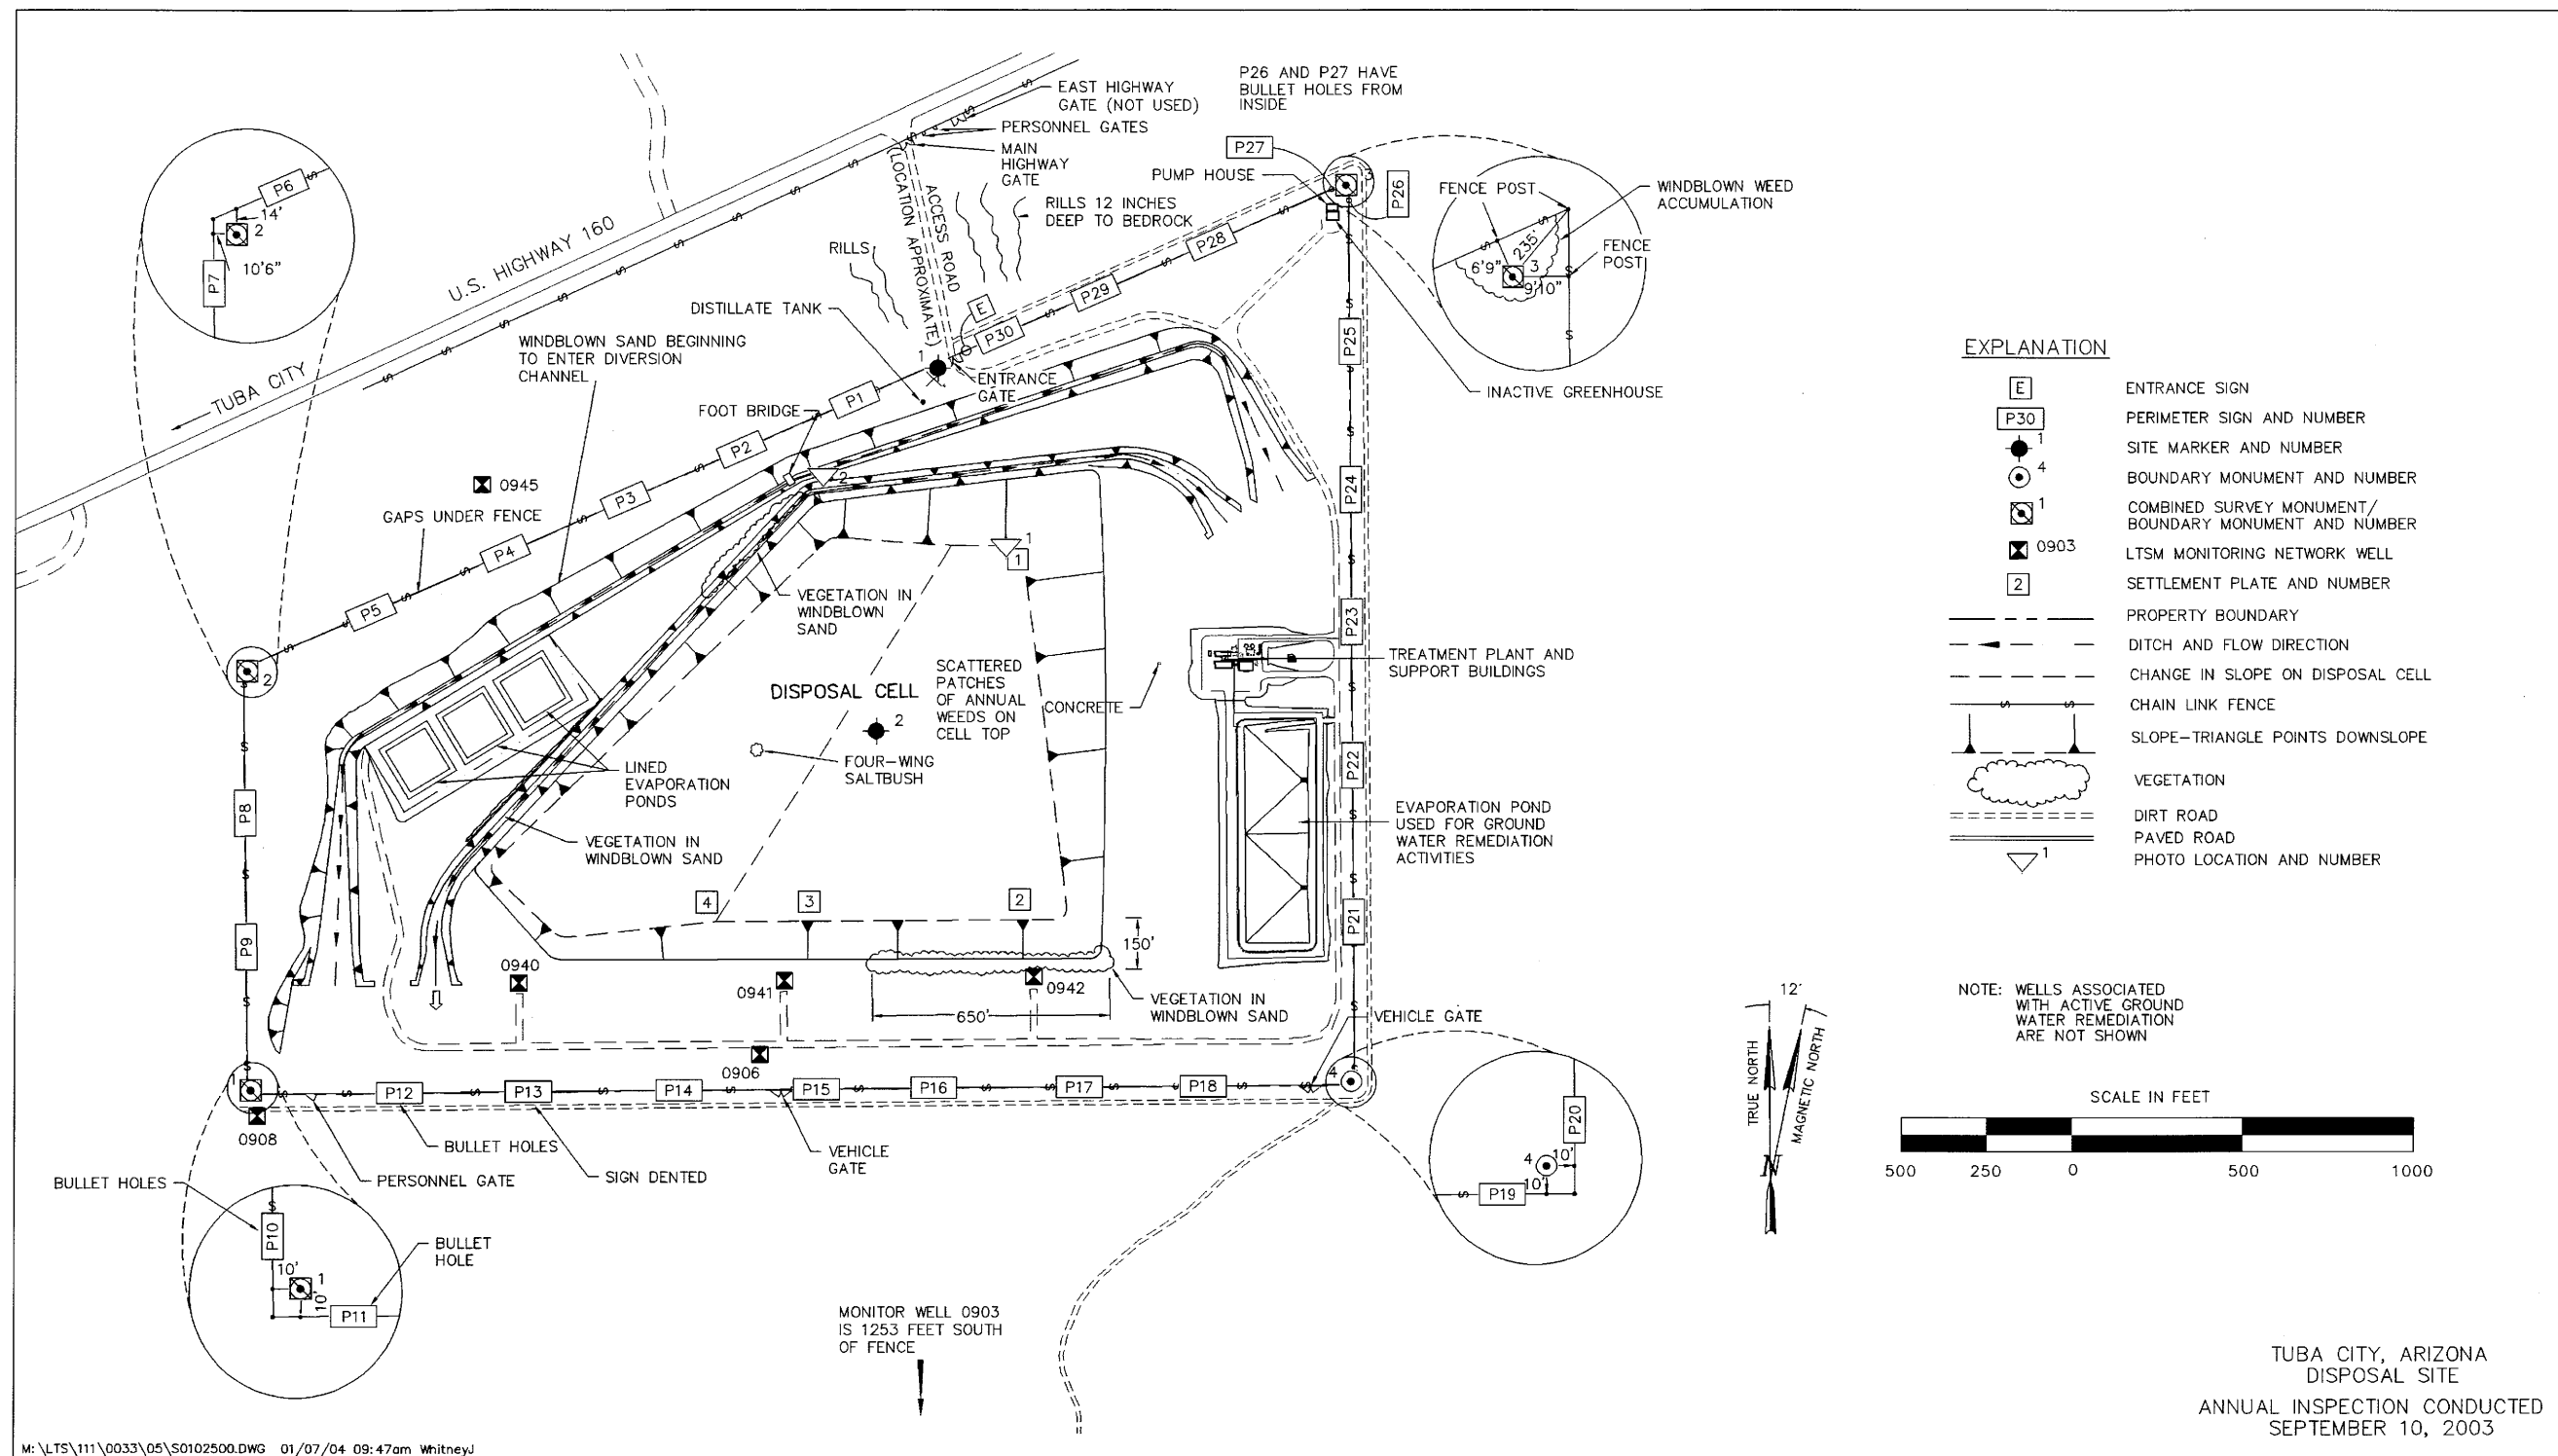
The site, located east of Tuba City, Arizona, was inspected on September 10, 2003. Results of the inspection are described below. Features and photograph locations (PLs) mentioned in this report are shown on Figure 19-1. Numbers in the left margin of this report refer to items summarized in the Executive Summary table.

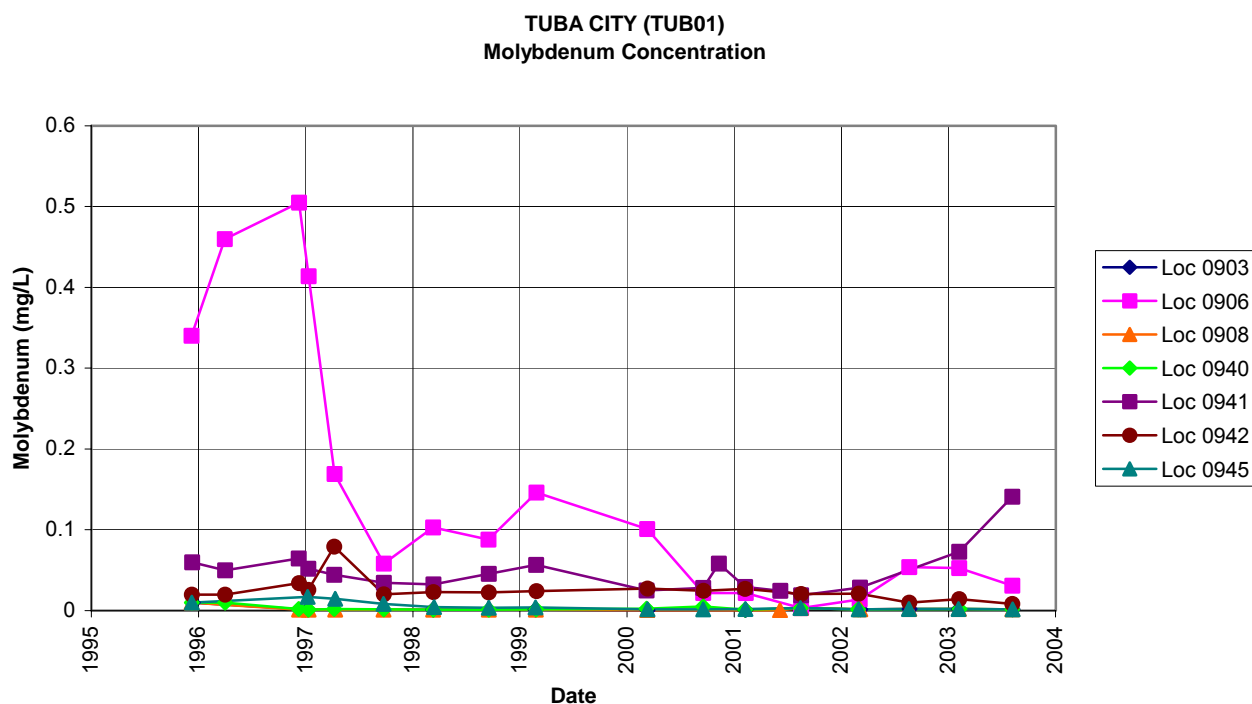
Figure 19–2. Time-Concentration Plots of Molybdenum in Ground Water at the Tuba City, Arizona, Disposal Site

Molybdenum concentrations exceeded the 0.1 milligram per liter (mg/L) standard in the sample from monitor well MW–0941 in 2003. Except at MW–0906, molybdenum concentrations have not varied significantly in the last 8 years (Figure 19–2). Samples from MW–0906 typically have had higher and more variable molybdenum concentrations in the past than samples from other wells.

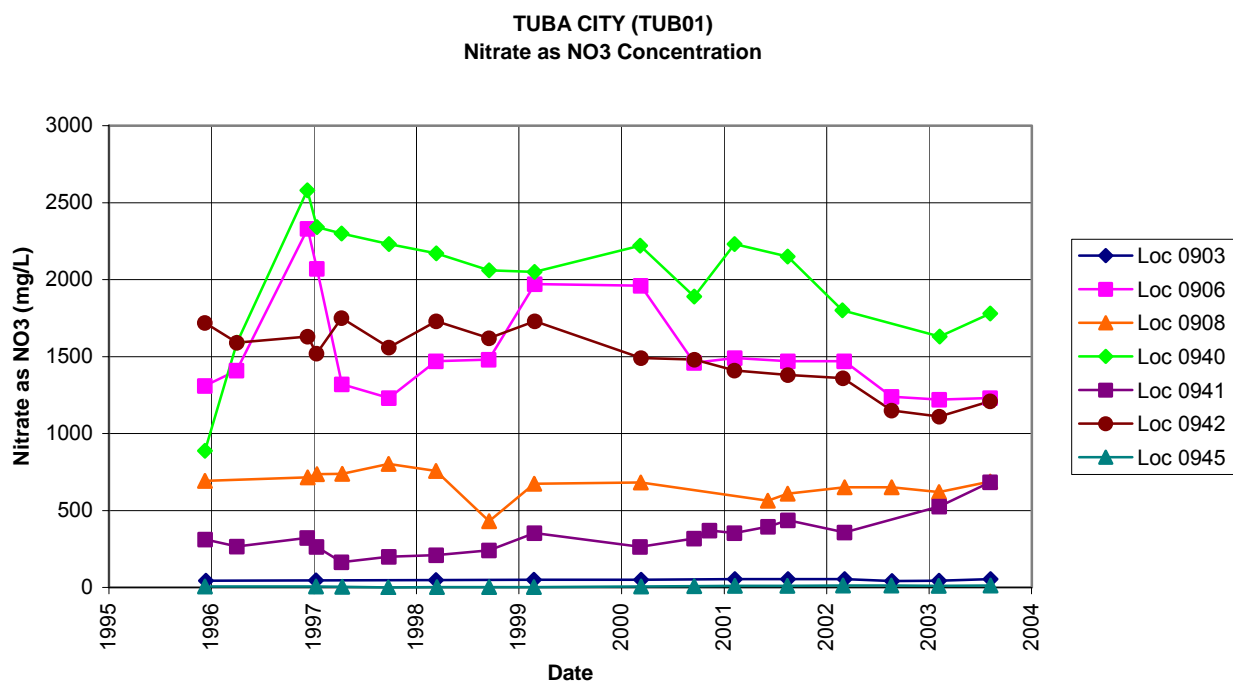
Figure 19–3. Time-Concentration Plots of Nitrate (as NO₃) in Ground Water at the Tuba City, Arizona, Disposal Site

In 2003, concentrations of nitrate (as NO₃) exceeded the 44 mg/L standard in samples from all monitor wells except background well MW–0945. Between 2002 and 2003, no significant increases or decreases in concentrations were observed in samples from any well, although concentrations varied considerably—by more than two orders of magnitude—from well to well (Figure 19–3).

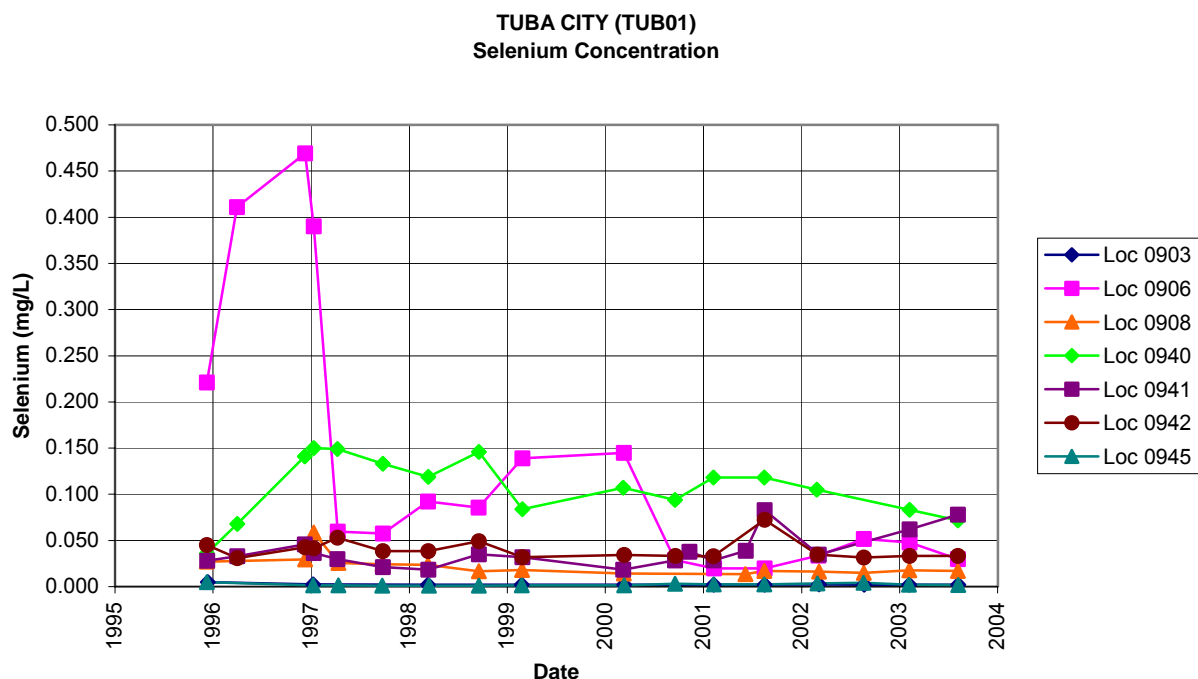
Figure 19–4. Time-Concentration Plots of Selenium in Ground Water at the Tuba City, Arizona, Disposal Site

Consistent with historical data, selenium concentrations exceeded the 0.01 mg/L standard in 2003 in samples from all wells except background well MW–0945 and off-site, downgradient well MW–0903. Selenium values have remained fairly consistent in samples from all wells except MW–0906 and MW–0940 (Figure 19–4).

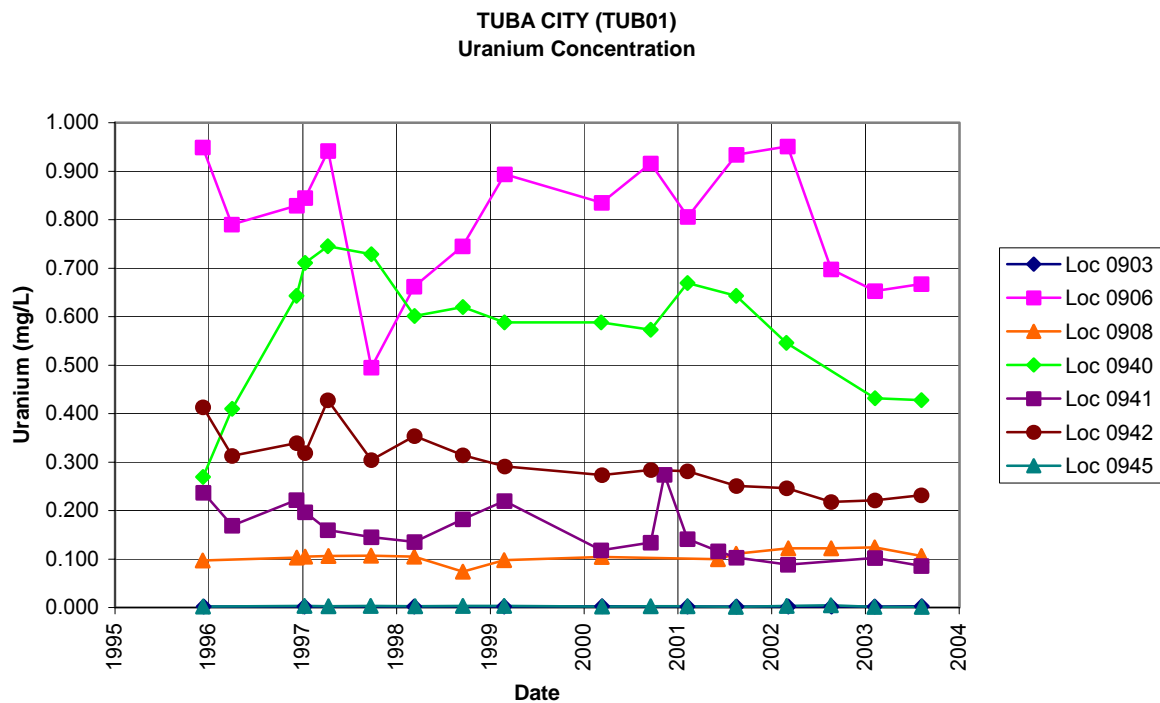
Figure 19–5. Time-Concentration Plots of Uranium in Ground Water at the Tuba City, Arizona, Disposal Site

Uranium concentrations exceeded the 0.044 mg/L standard in 2003 samples from all wells except background well MW–0945 and off-site, downgradient well MW–0903. Concentrations have remained fairly constant over time in samples from all wells except MW–0906 and MW–0940 (Figure 19–5).

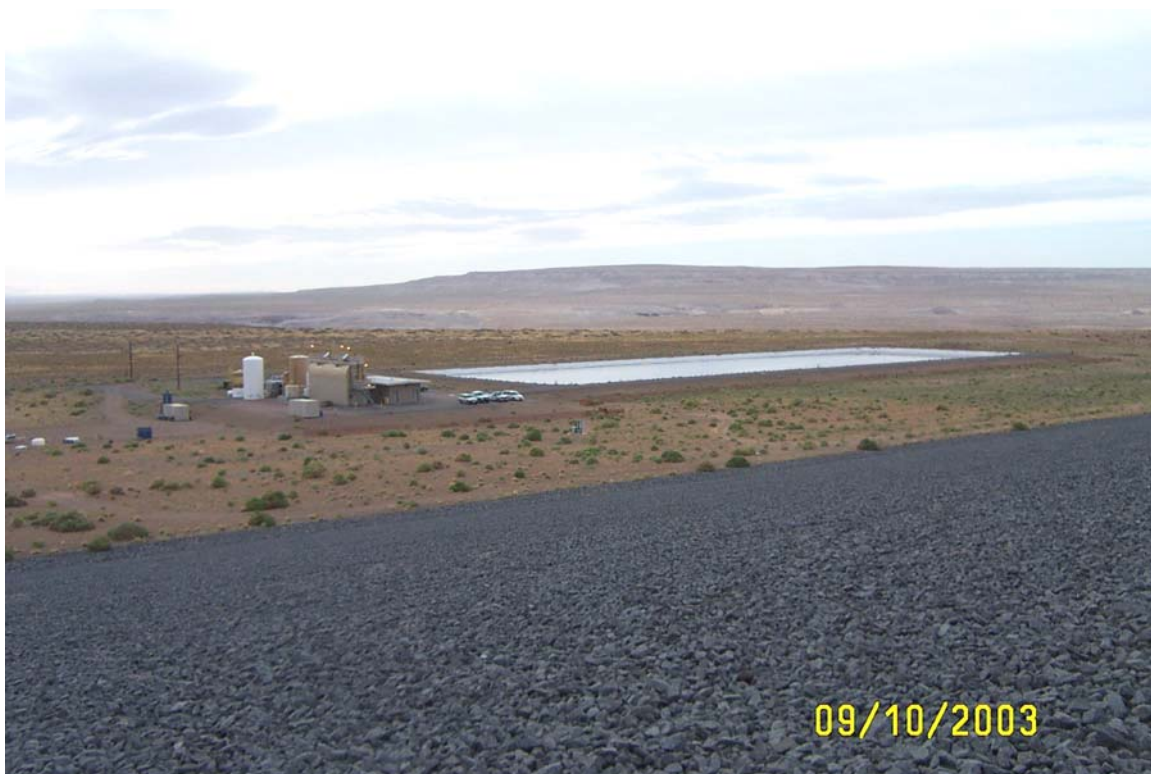
Disposal Cell—The disposal cell is covered with riprap for erosion protection. The rock was in excellent condition. Inspectors discovered no evidence of slumping, settling, or instability on the top or side slopes of the disposal cell (PL-1).

TUB 9/2003. PL–1. East side slope of the cell and adjacent ground water remediation facilities.

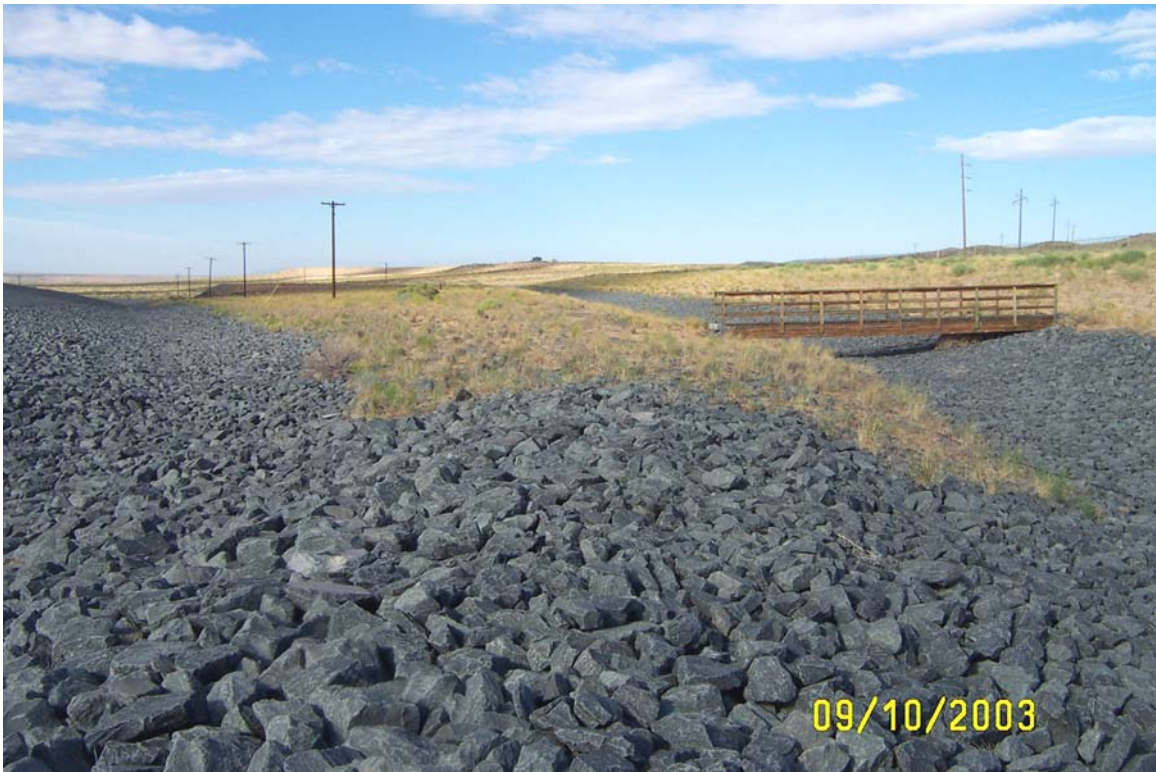
Two rock-lined drainage channels are located on the north (upslope) side of the disposal cell. The outermost channel intercepts storm water and diverts it around the disposal cell to the south and east. The inner drainage channel, constructed at the toe of the north and northwest sides of the disposal cell, collects runoff from the disposal cell itself and diverts it to the south and east as well. Sand accumulation in the inner diversion channel and in the northwest segment of the outer diversion channel was unchanged since the 2002 inspection and does not interfere with the drainage function of the channels (PL-2).

TUB 9/2003. PL-2. Sand accumulation and vegetation between the toe drainage channel (left) and the storm water diversion channel (right).
